Character-Defining Features of Contributing Buildings and Structures in the Fort Gordon, Georgia, Signal School Campus Historic District

Sunny E. Adams and Adam D. Smith

July 2016

Under Project 450904, "NHPA Building Evaluations at Fort Gordon"

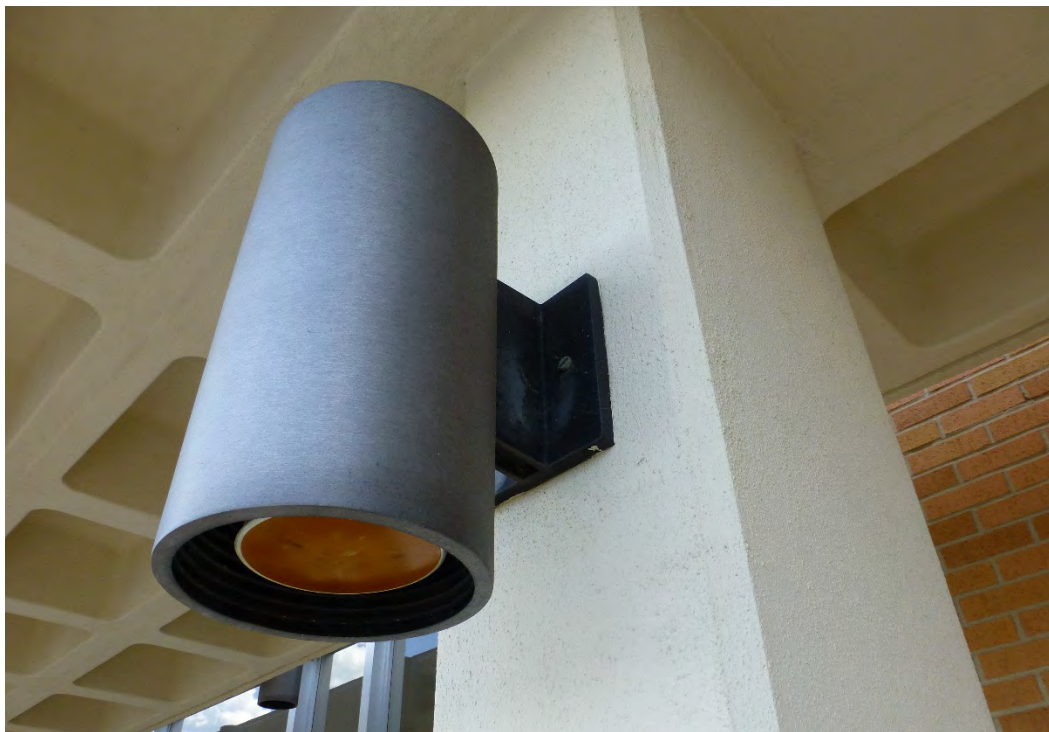
Figure 79. In-kind replacement cylinder—bronze wall-mounted light fixture—located near the main entry on the south elevation of Building 25810, Brant Hall (ERDC-CERL, 2015).

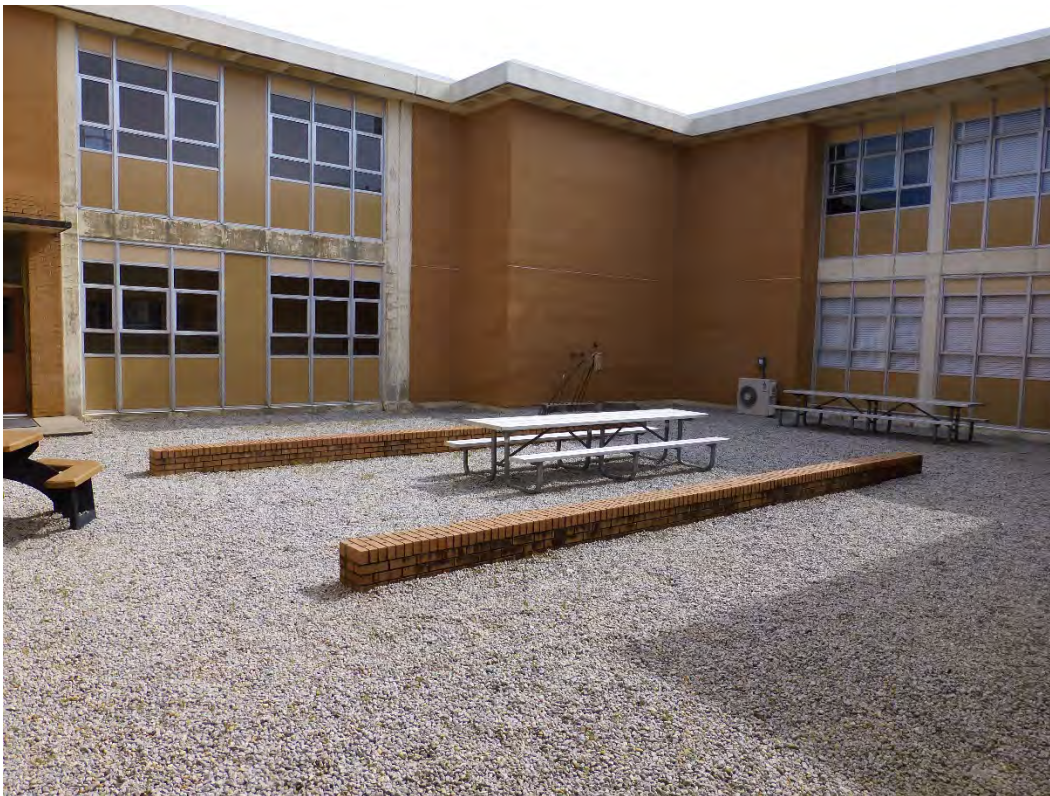
Figure 92. Interior view of the west courtyard in Building 29813, Allen Hall, showing the window bays and parallel brick sitting walls. Note the absence of vegetation that has been removed and replaced with gravel infill (ERDC-CERL, 2015).

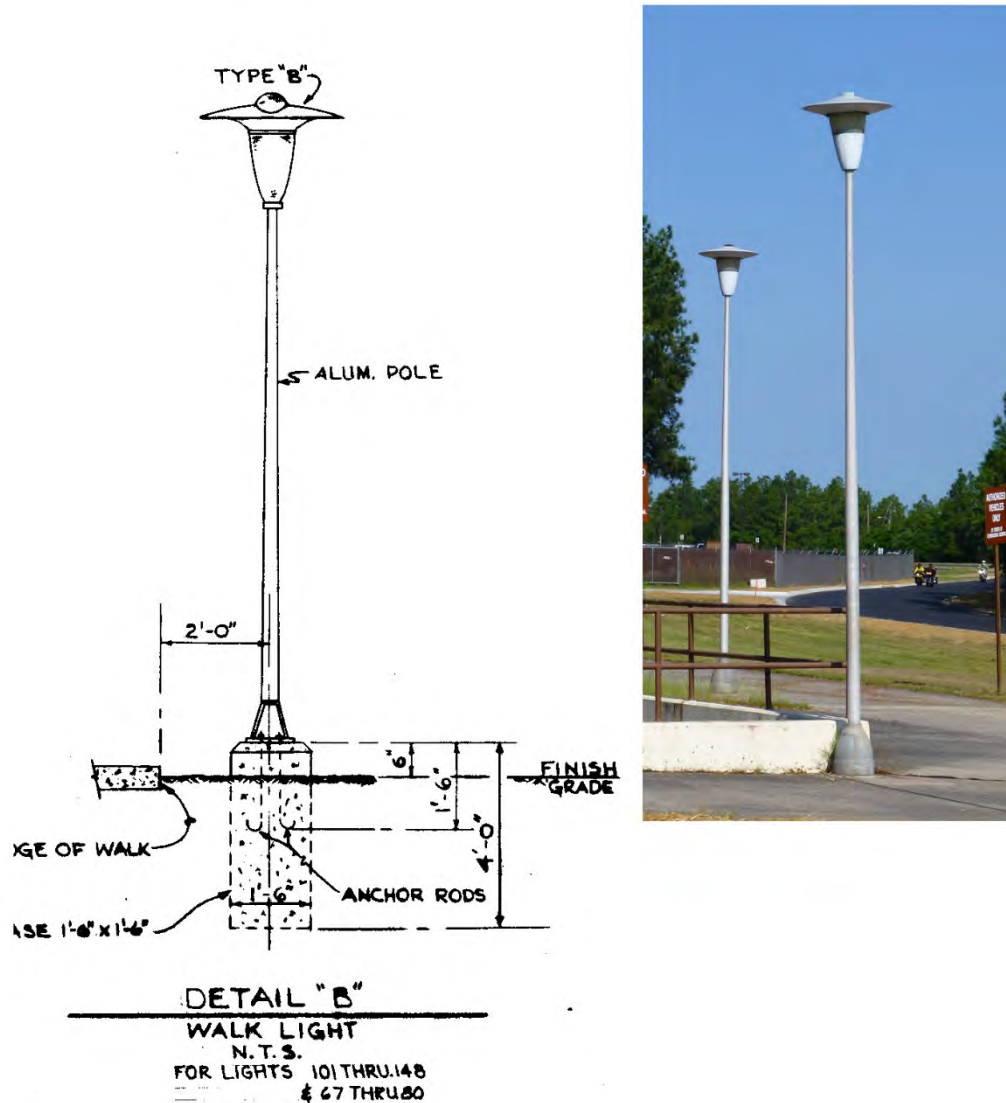
Figure 120. An example of one type of the replacement sidewalk lights (ERDC-CERL, 2015).

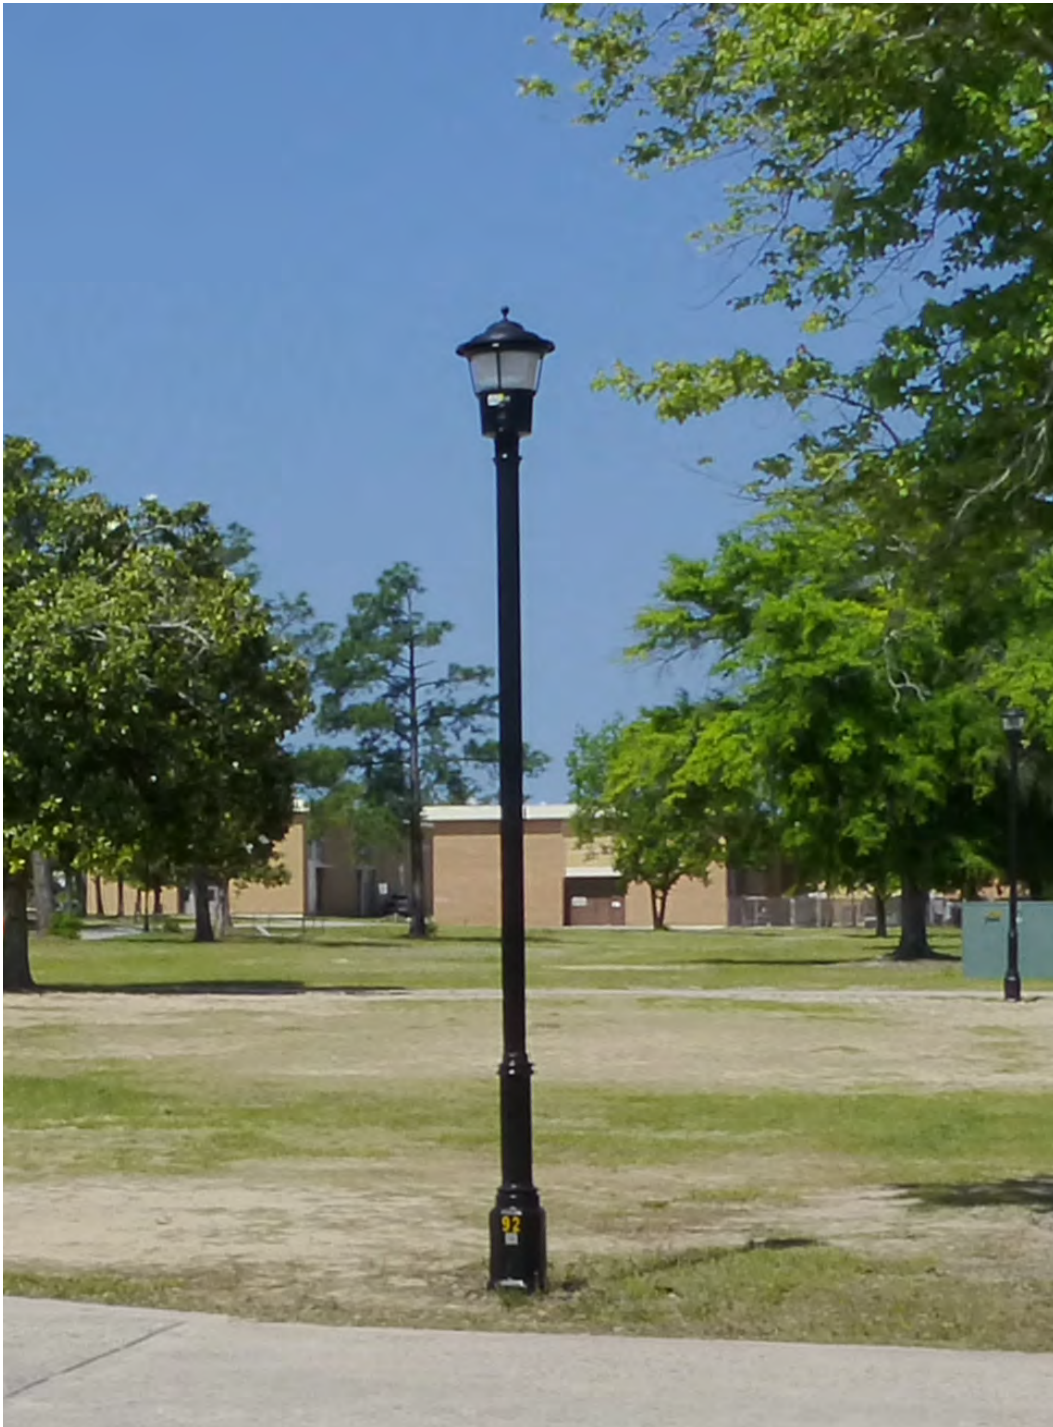
Figure 121. An example of one type of the replacement sidewalk lights (ERDC-CERL, 2015).

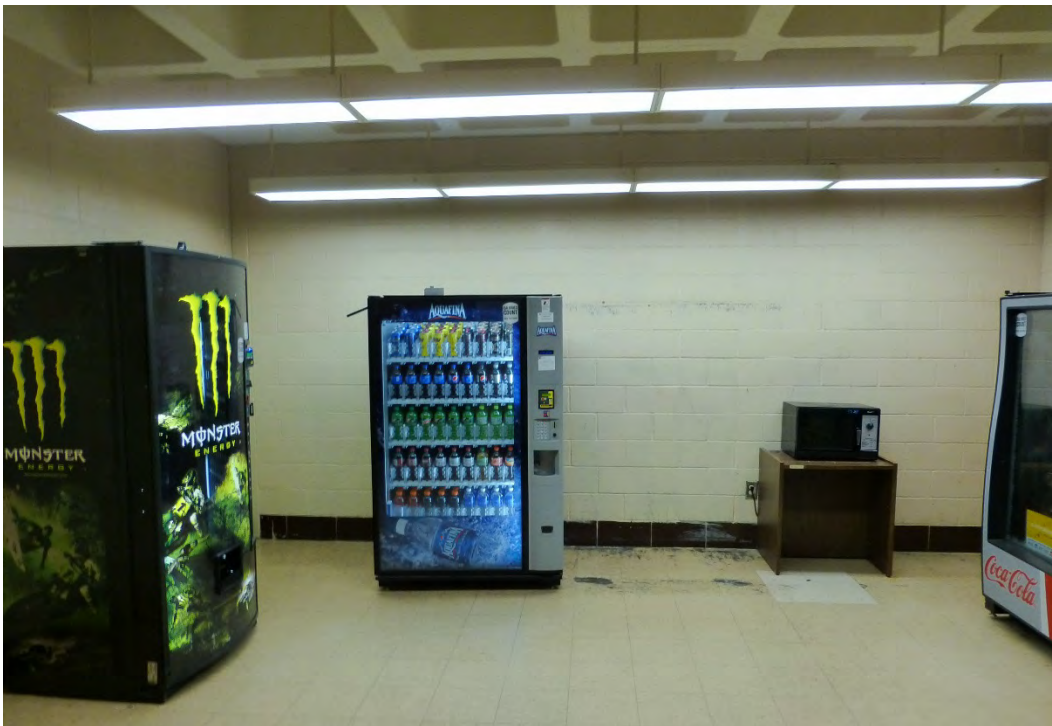
Figure 163. Example of a modified open vending area (ERDC-CERL, 2015).

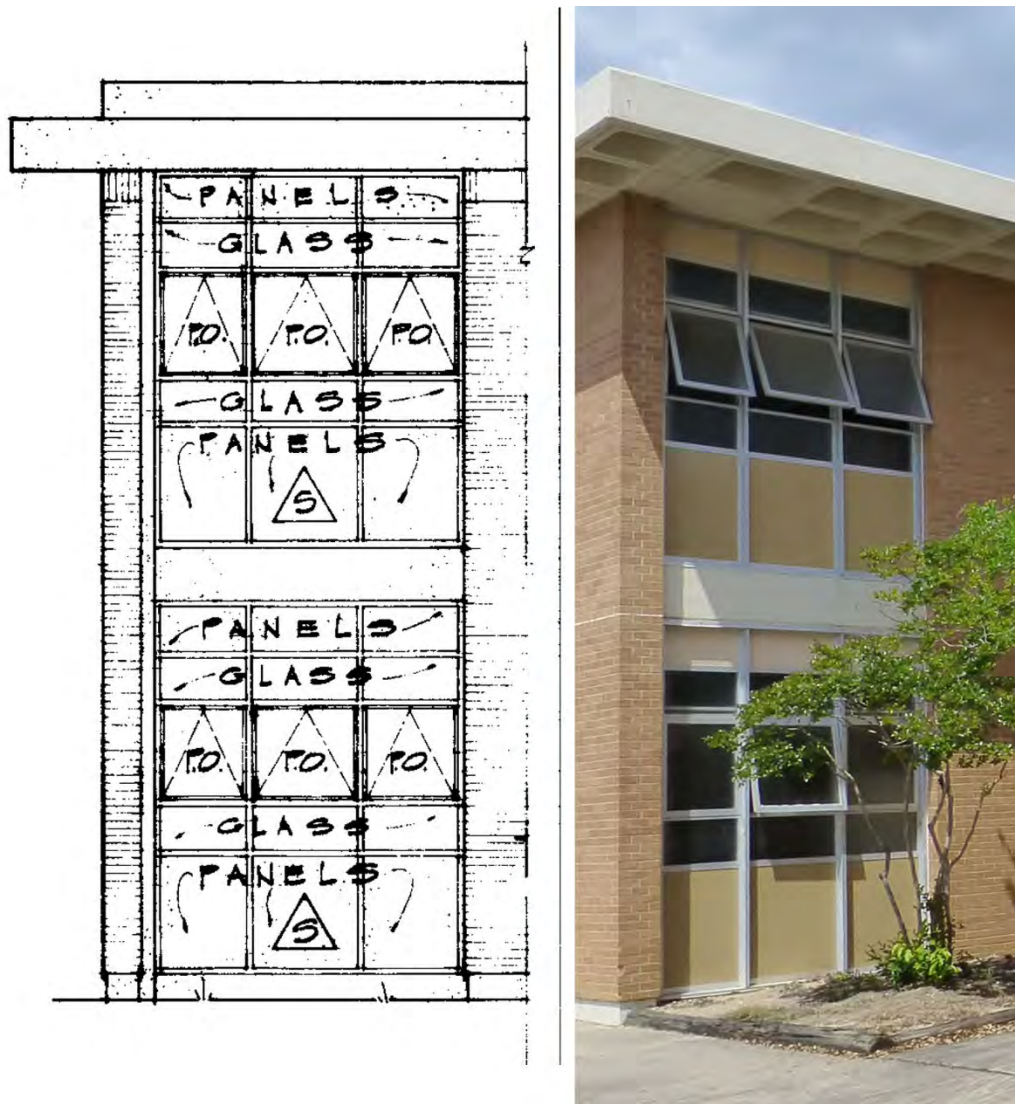
Figure 222. Window bay - comparison of the original drawing detail from 1966 [left] to the current condition of the replacement bright-aluminum windows [right] (ERDC-CERL, 2015).
